Stress measurements at load-bearing components of the shaft steelwork and the mine hoist frame in the Regis Shaft of the Wieliczka Salt Mine

The study summarises the selection of dedicated techniques and procedures for measuring real stresses arising in shaft steelwork components due to car-shaft steelwork interactions as well as stresses at critical points of the car frame in the elevator installation in the Regis Shaft of the Wieliczka Salt Mine. The implemented solution and operational parameters of the hoisting installation in the Regis Shaft of the Wieliczka Salt Mine are summarised, the adopted measurement method and dedicated equipment are presented, focusing on the procedure for locating the critical points on the car frame and shaft steelwork. The purpose-built measurement set-up as well as the adopted stress measurement procedure and results are explained in detail.

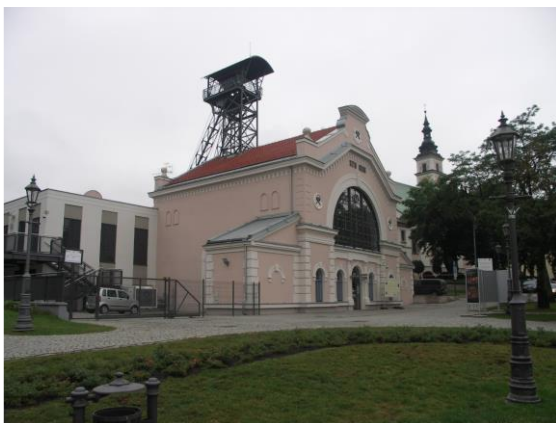
Fig. 1. The top of the Regis Shaft [3]

In order that the shaft top facility should remain as a heritage asset, the conservation officer decreed that the winding tower +24.26 m high, located on the level +21.05 m and housing rope pulleys, should be brick-lined and maintained as a piece of architecture (Fig. 1).

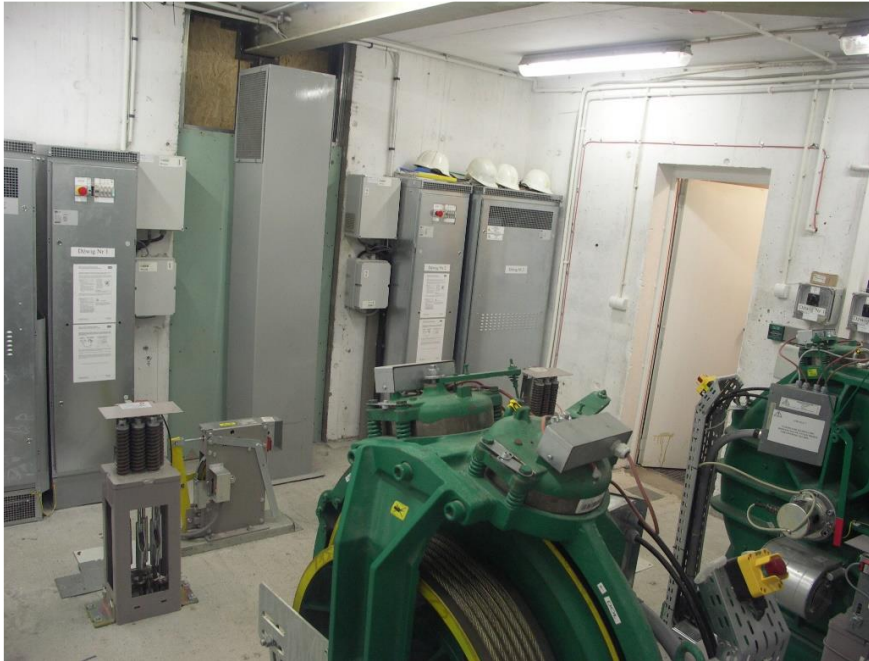
Fig. 3. Machine room with installed gearless winches MX18 with the friction pulleys 690 mm in diameter [3]

A general view of the machine room is shown in Fig. 3 and the hoist shaft with wall-mounted equipment is shown in Fig. 4. Fig. 5 gives a vertical cross-section of the top part of the hoist tower, a view of the machine room and the upper section of the shaft.

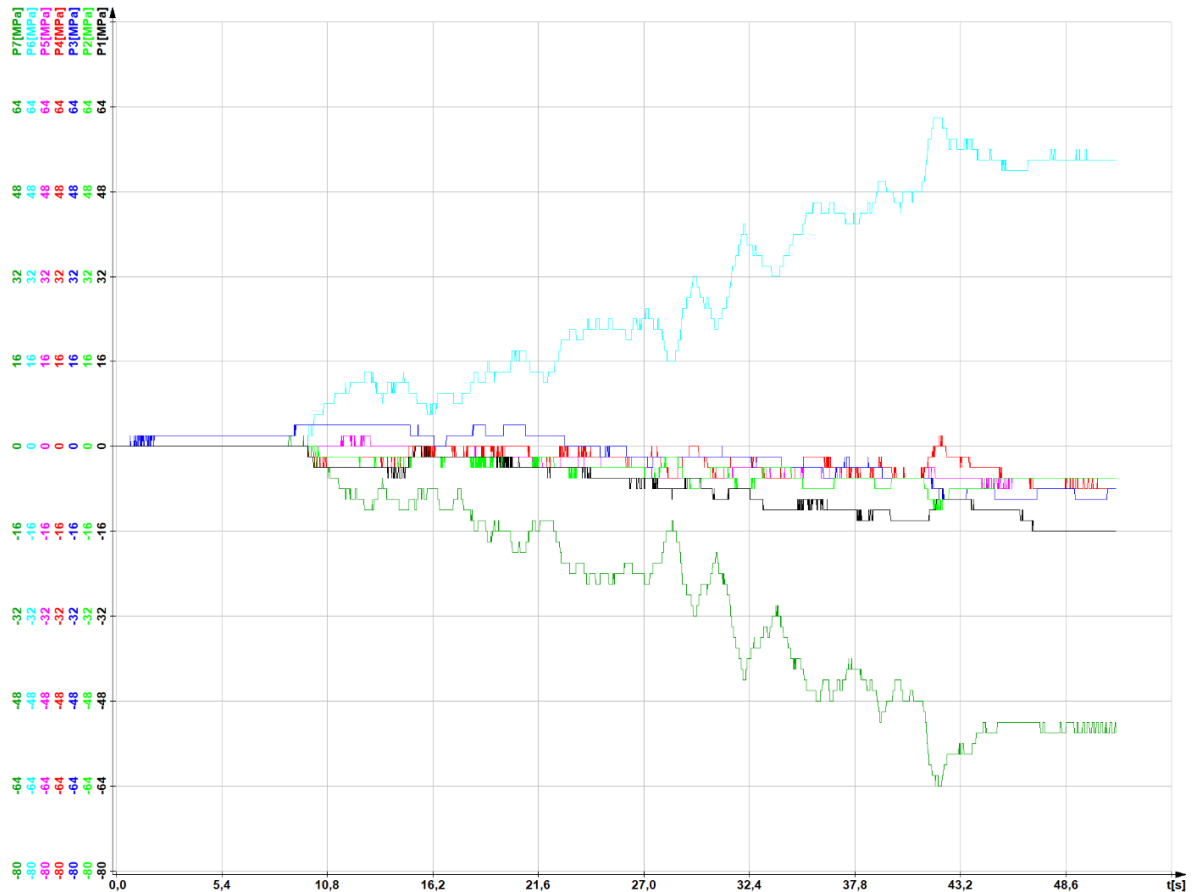
Fig. 12. Downward ride of the elevator car at 4 m/s, with no load [7]

The first series of car frame tests were conducted during the ride at nominal speed. The standard hoisting speed during the normal operation was 4 m/s, with no load carried $Q=0.0$ kg. Fig. 12 plots the stress increase registered by individual strain gauges during the ride from the bank level station 1 down to the level – 135 m.

During the first 9 seconds minor stress changes are registered by strain gauge 3, that is the time when the car doors and station doors are opened and closed. Afterwards, the elevator is started and the car begins to ride downward. Successively, with the metres travelled the stress tends to increase, which is registered by strain gauges P6 and P7. These stress increases result from the changes in loading due to the tail rope self-weight and the floor beam may experience slight bending and torsion. Forces and moments of forces that cause this effect are due to the changes of tail rope weight and tail rope motions. In the period from 43rd and 47th second, the car decelerates before reaching the bottom level station. Between the 47th and 49th second an opening of car doors occurs. The further part of the graph does not need to be considered because it reveals disturbances associated with the servicemen entering the car.

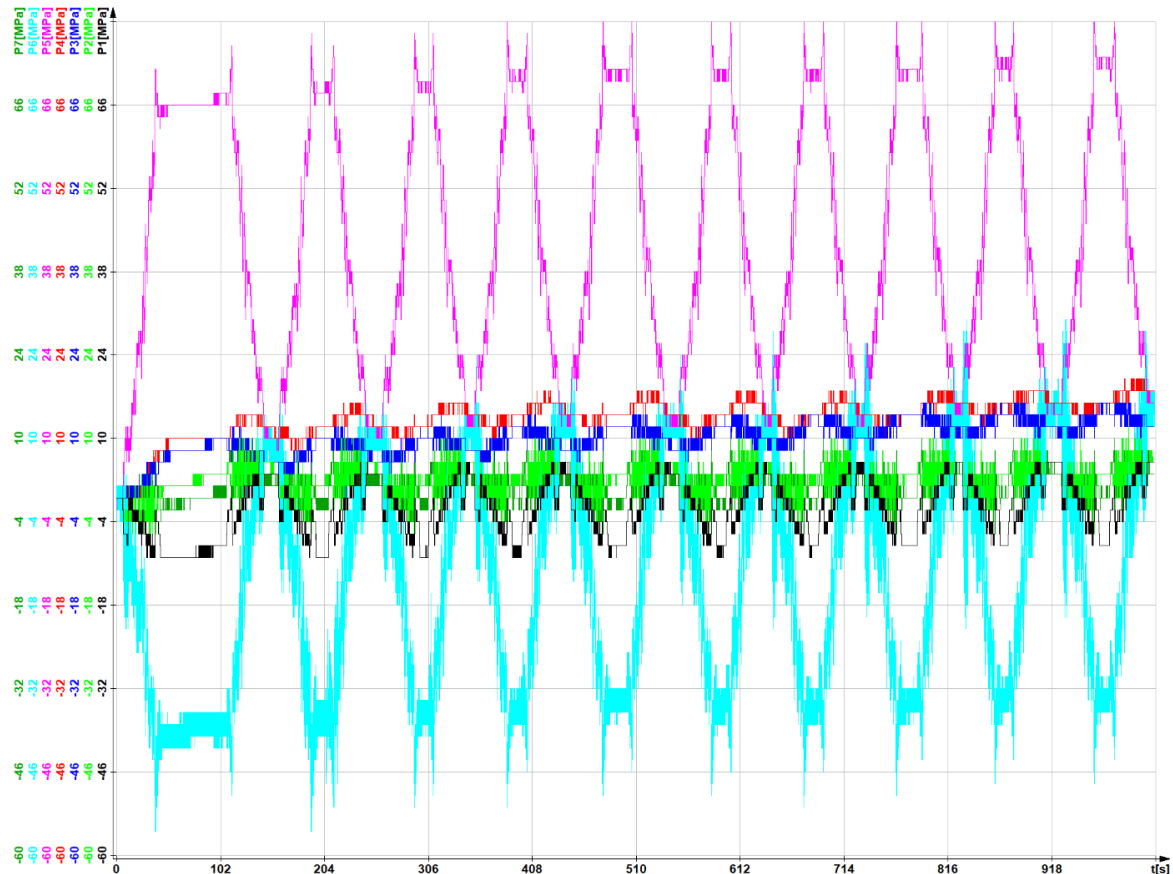
Fig. 13. 10 cycles of elevator car ride at $v=4$ m/s, with full load [7]

In the second series of tests, the elevator car travelled with the maximal load in the standard ride mode at 4 m/s, carrying the load of $Q=1600$ kg. Fig. 13 shows the results registered throughout 10 cycles of the car ride with the maximal values of operating parameters designed for this model of the elevator.

It is worthwhile mentioning that the maximal stress increases were registered again by strain gauges mounted on the floor beam, especially by P5 and P6, which is indicative of torsional moments arising due to tail rope self-weight load, and of the acting bending forces due to elevator car loads. The maximal stress increases tend to oscillate, fully revealing the impacts of the dynamic behaviour of the system. While the elevator stops, the stress tends to decrease until the momentary change of sign in the final stage of deceleration, which is readily apparent between the duty cycles, especially in readouts from strain gauge P6.
